# First Nation Mould Remediation Case Study

## Montreal Lake Cree Nation

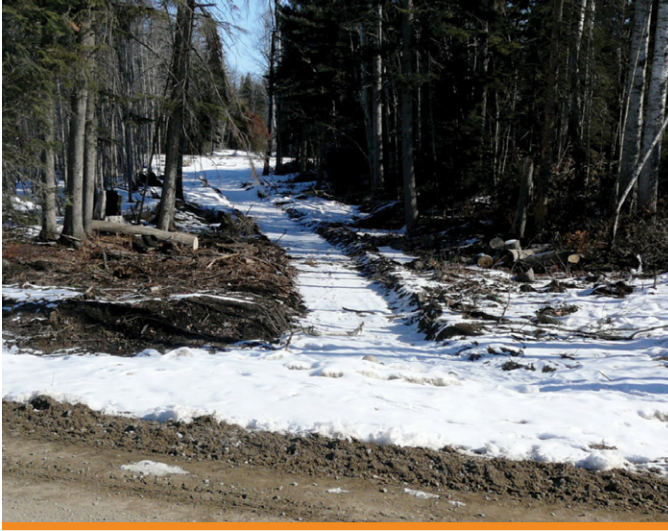
**Figure 2** Drainage path/floodway used through the forest to better manage surface water in community

The community applied for flood remediation funding from Aboriginal Affairs and Northern Development Canada (AANDC) to implement a comprehensive drainage plan. The plan was laid out in four phases, which will eventually serve the entire community. The first two phases of the stormwater management project, namely, ditching and building culverts and establishing water courses, have been completed (see figures 2 and 3). Completion of the next two phases is expected when the community acquires adequate funding.

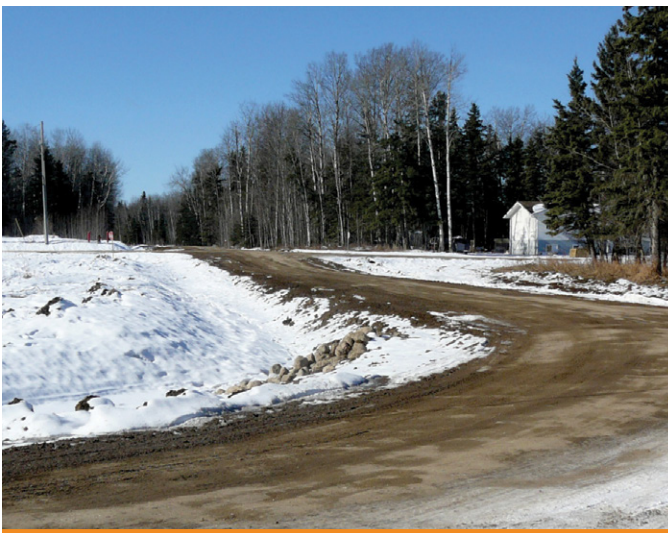
**Figure 3** Ditching/culvert system is also used to manage surface water in the community

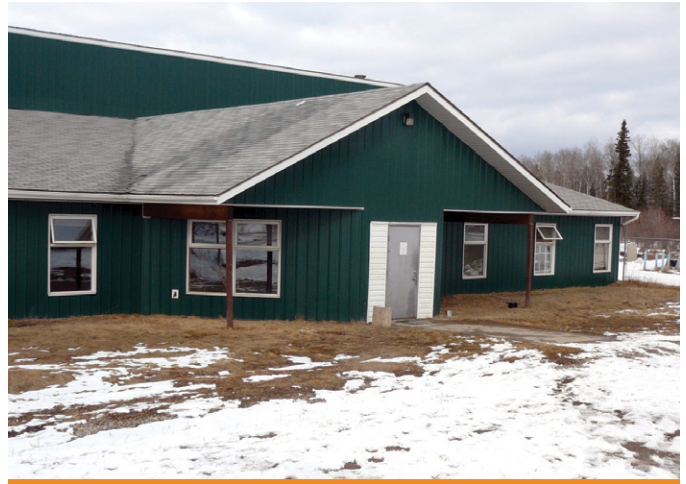
**Figure 4** Montreal Lake Cree Nation’s housing office is situated below the level of the nearby roadway, such that surface water is directed toward the building

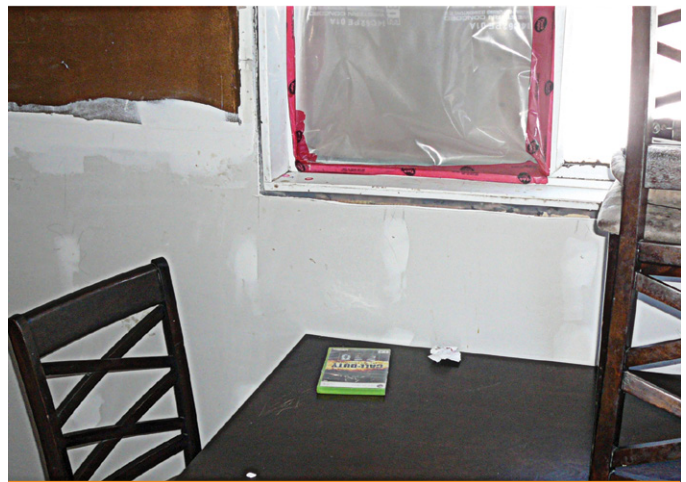
and air sealing. Vandalism and broken windows only added to the problem, since the solution over the years had been to place plywood over the openings. This left the potential for rain penetration around the plywood in the summer and excessive frost and condensation on the surface of the plywood in the winter, which wetted the structure below the windows, leading to mould, not to mention the potential for safety concerns related to egress.

**Figure 5** Drywall repairs below a previously broken window where mould was growing

At the time of writing, 20 houses were still on the list for mould remediation and set to have windows installed or replaced to complete the repairs. “Chief and Council approved the project, and we are going to put a policy in place to make the tenants responsible for their windows,” Clarice said. The First Nation will replace

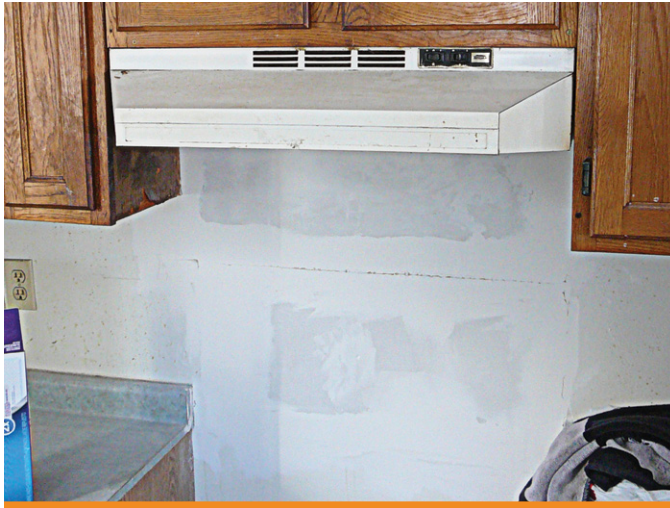
**Figure 6** Drywall repairs behind a stove where mould was growing

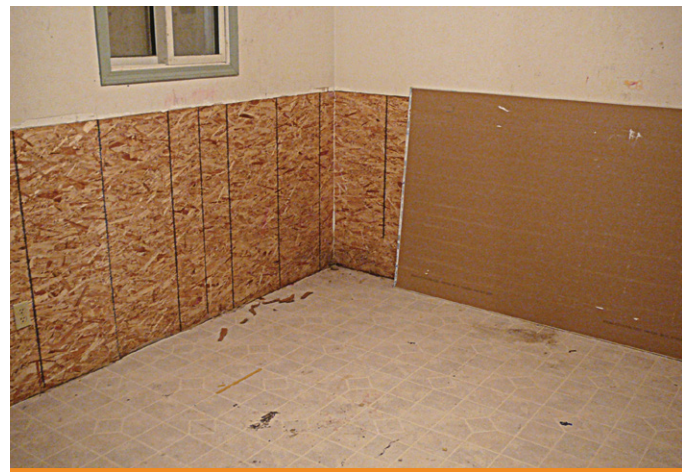
**Figure 7** Drywall removal and replacement in a previously flooded basement

Flood damage repair to community houses was covered by insurance, and an extensive cleanup plan was set up. The cleanup activities included drying out basements, gutting wet material that could not be dried quickly enough, replacing furnaces and repairing the overall damage. However, while dealing with repairs caused by the flooding, other mould issues came to light. It was noted that these mould issues had been caused over the years by a combination of factors, including construction flaws, occupant behaviours, plumbing problems and inadequate ventilation.
