First Nation Mold Remediation Case Study

Tsartlip First Nation

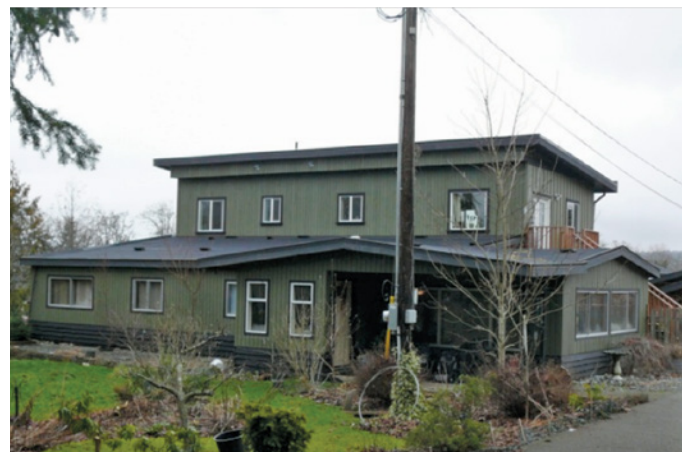
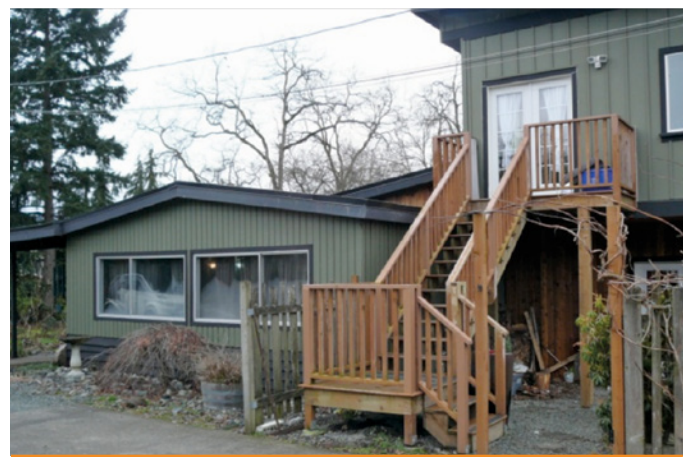
Figure 3 and 4 Street view of a mold remediated house with a new apartment on the second floor

One of the strengths of Tsartlip's housing stock is the different types of housing units to meet the different needs of community members (figures 3 and 4). The Tsartlip leadership believes that high quality affordable rental housing is an important first step for young families—families who would become the homeowners of the future. Recently, several young families (with the support of Tsartlip) have entered into loan agreements to build their own homes.

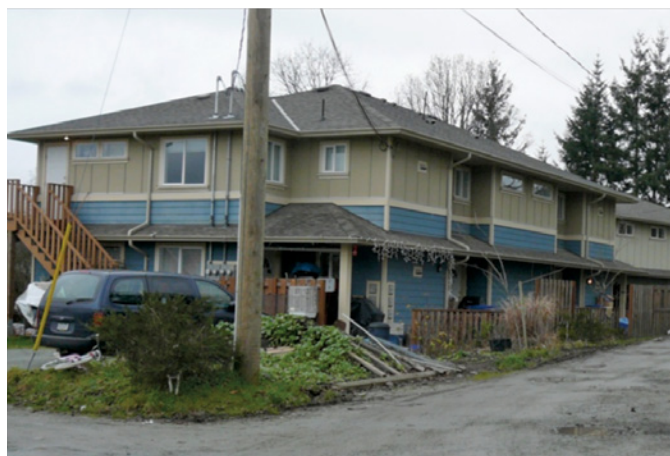
Figure 5 Newly constructed back-to-back fourplexes in Tsartlip

The building of new projects now demonstrates the knowledge and experience gained by the community through the mold remediation process. Several years after the mold project was completed, 39 homes were constructed almost exclusively by these same Tsartlip skilled workers. (figures 5, 6, 7 and 8) They organized themselves into specialized trade crews and now know about site safety, quality assurance inspections and work protocols. As a result, they build houses to a much higher standard than before. The community takes pride in having its own people and tradespeople build and work on its houses.

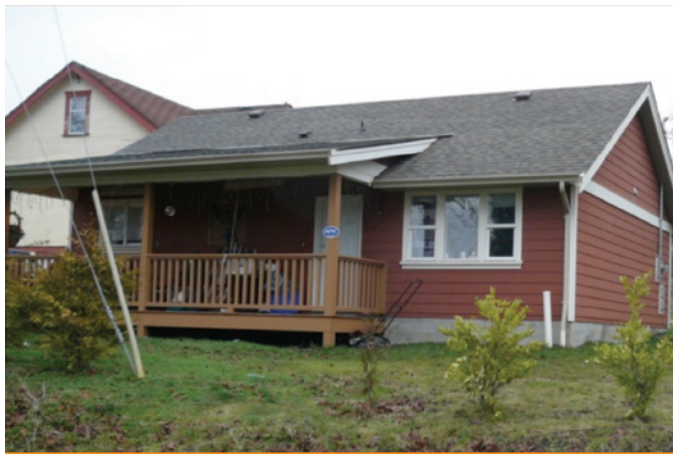
Figure 6 Newly constructed flat for senior community members

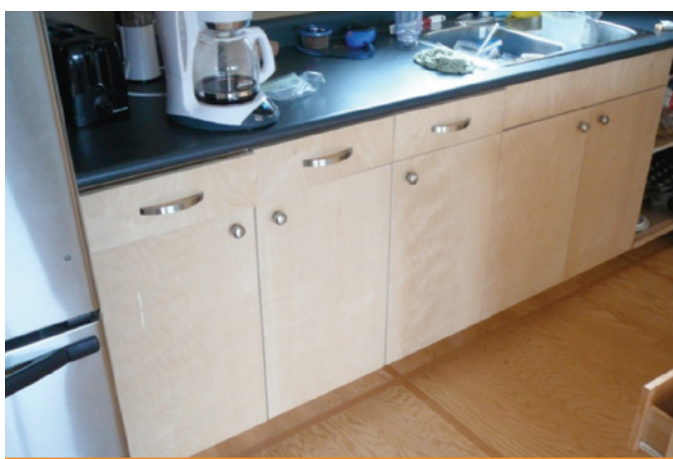
Figure 7 Mold remediated house showcasing locally made kitchen cabinets and varnished plywood floor

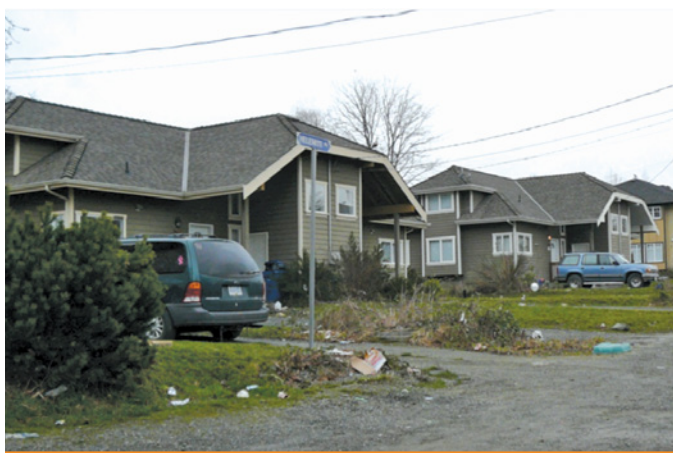
Figure 8 A series of new semi-detached homes in Tsartlip
