# Post- Occupancy Evaluation

Salus Karen's Place  
Supportive Housing  
Project

# Post-Occupancy Evaluation of the Salus Karen's Place Supportive Housing Project

August 2020

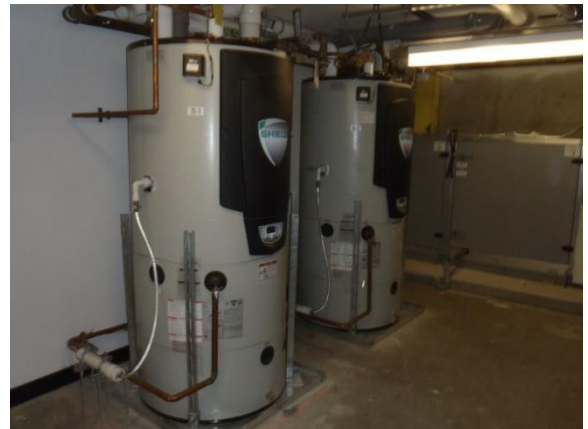
Ideally, under the Passive House design concept, internal heat gains, heat recovery units, and pre-conditioning of make-up air should be nearly sufficient to meet the building's heating needs. However, based on the calibrated building energy model, it seems that in-unit baseboards provided half of the building's heating needs (*Figure 35*).

Figure 34: Condensing Water Heaters that Provide Space Heating and DHW to the Building

<sup>42</sup> It is unusual to have three-way valve when using VFDs and this configuration should be re-examined to see if using a two-way valve or restricting the bypass port of the three-way valve should be considered.

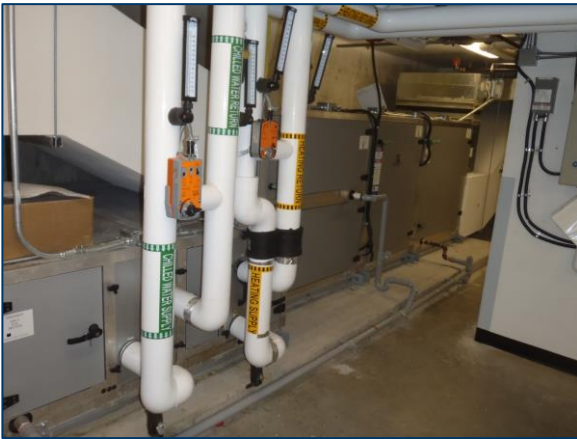
A central make-up air unit located in the basement is used to provide ventilation to each apartment. The flow of air is controlled by a variable air volume valve for each apartment. The typical minimum flow setpoint was observed at 11 L/s with a maximum of 22 L/s. This make-up air unit has a glycol heating section as well as a hydronic cooling section and is a variable flow unit. It also has an energy recovery section based on an alternating flow plate-type heat exchanger. Therefore, this unit allows recovering the exhaust air to preheat or precool the incoming outdoor air. The supply and exhaust motors have Variable Frequency Drives (VFDs) since the unit is designed as variable flow. The unit was modified in the fall of 2018 to increase the size of the supply fan motor from 1.5 hp to 2 hp with the aim to increase the flow in order to reduce some of the summer overheating issues that were observed in 2018. This lack of capacity explains the trending data which shows that the unit's EFVs are always operating at 100% speed. No formal airflow measurement was taken or provided following the replacement of the motor from 1.5 hp to 2 hp.

Figure E - 1: ERV Serving the Building

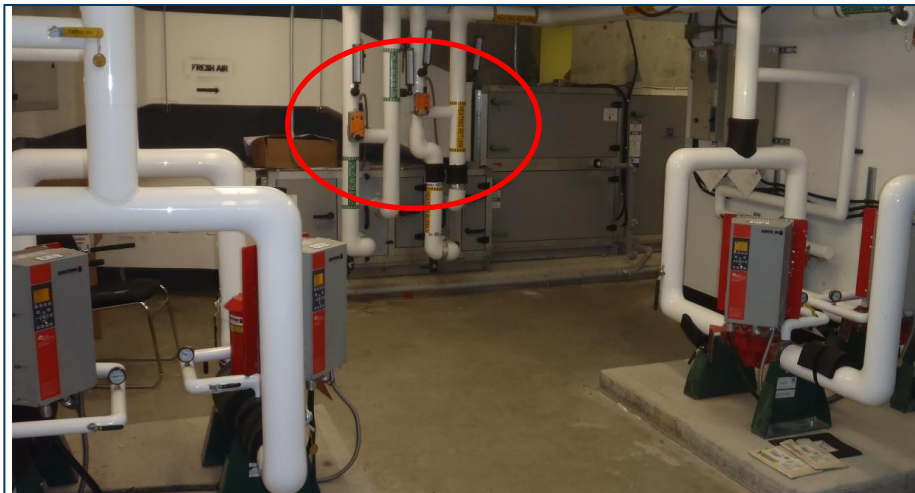
**Figure E - 3: Heating and Cooling Pump and Three-way Valves (Ref. to red circle)**

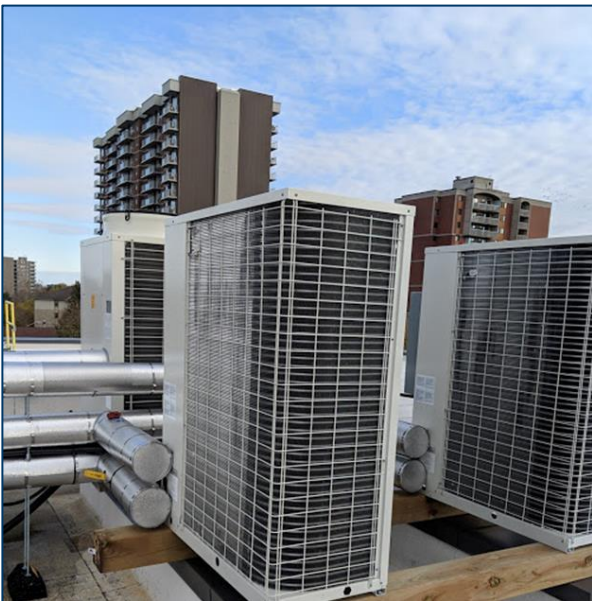
**Figure E - 4: Air Cooled Chillers – New Units (2x) in Front, Existing Unit (back)**
