FIRST NATIONS MOLD REMEDIATION CASE STUDY

Eel River Bar First Nation

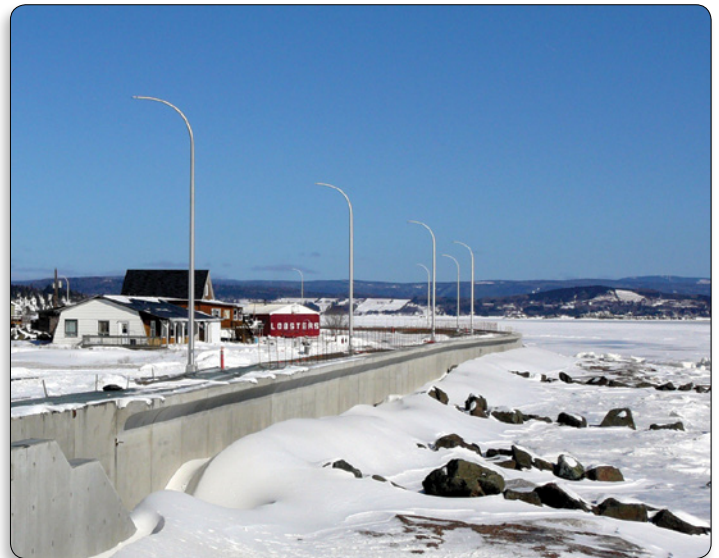
Figure 1 Dike and concrete seawall along the Atlantic Ocean shoreline of the community built after an ocean surge caused by a severe storm flooded houses in 2010.

In September 2011, the First Nation began housing repairs, renovations and relocations. Through determination and hard work the housing department, working in co-operation with the provincial Department of Municipal Affairs², created an inventory of 40 serviced lots ready for new construction. The housing manager's experience and skills at managing funds, record keeping and tracking procedures effectively streamlined housing operations. Since then, a dike and concrete seawall have been constructed along the Atlantic Ocean shoreline of the community (figure 1).

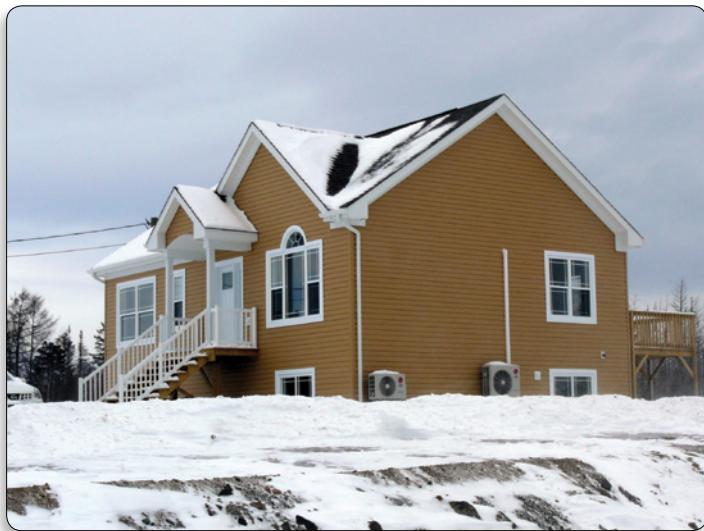
Figure 2 A newly built home with mini-split compressors on the exterior—one for the basement area and the other for the upstairs. Worthy of note is the height of grade built up above the level of the road and the height of the foundation out of the ground to provide natural light to the lower units.

- the use of efficient mini-split heat pumps that promote better air movement, even heat and improved moisture management, with two units typically installed—18,000-BTUH unit upstairs and a 12,000-BTUH unit downstairs (see figure 2). Electric baseboards still installed to provide backup heat;

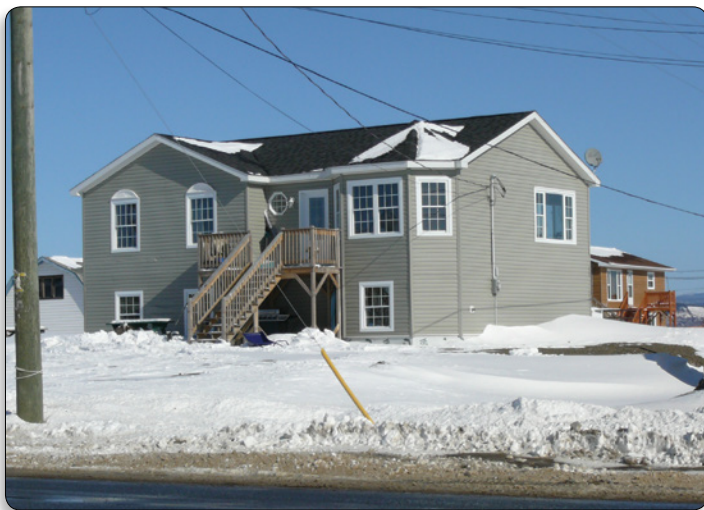
Figure 3 Newly built home with improved site conditions - the house is built on higher ground and was completed after conducting site inspections during construction.
