First Nation Mold Remediation Case Study

Membertou First Nation

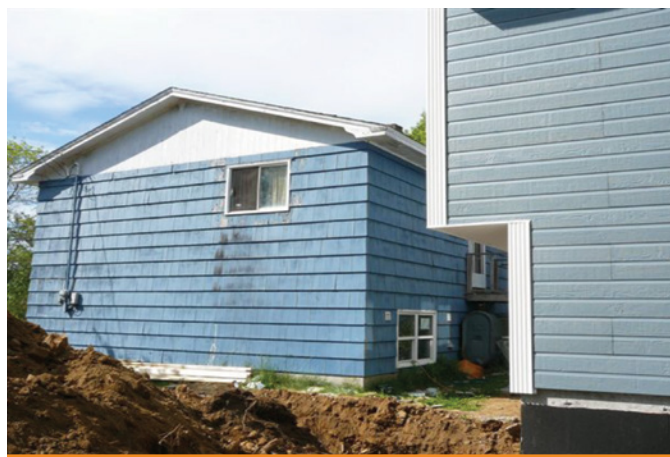
Figure 2 The house on the left had a history of leak problems and lack of maintenance. It is being replaced by the house on the right

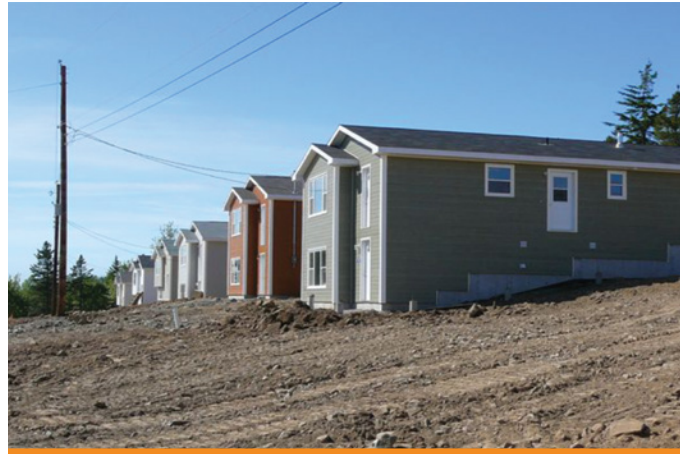
Figure 3 New hillside, basement-entry houses

Within the last few years, builders in the community are more aware of good water management practices including proper site grading, proper grade levels and placement of sod. For example, in the latest phase of construction, houses were built into a hillside with a basement entry on the street side to make better use of the space. The grading behind the houses was changed to improve surface drainage away from homes as shown in figures 3 and 4. Storm sewers have now been installed in the newer parts of the community, which provide better drainage.

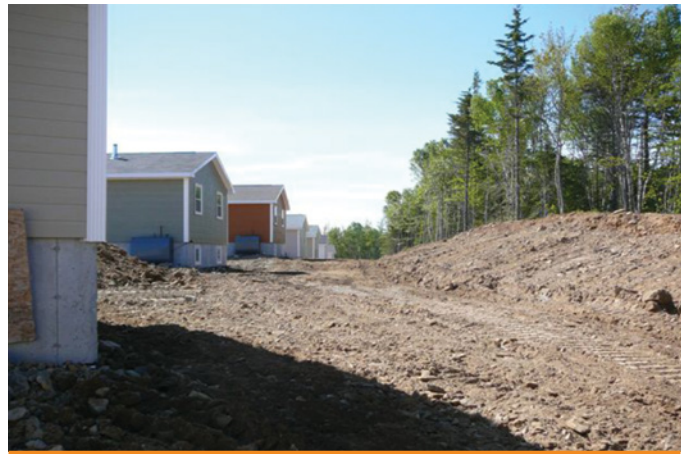
Figure 4 Improved surface drainage behind the hillside houses
